RADFORD UNIVERSITY

BMP INSPECTION REPORT

Project Number: 2429.3

Date: July 1, 2023

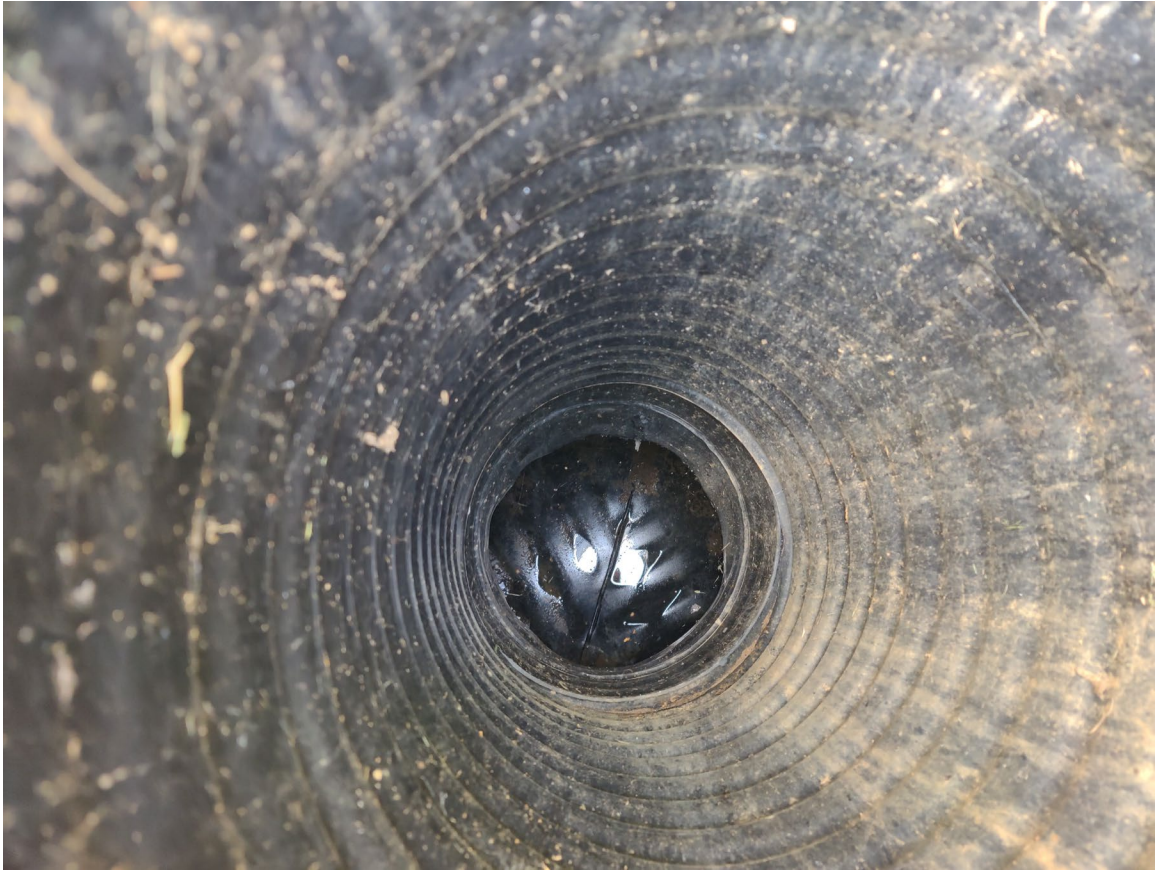
RU-BMP-IF-1 – UNDERGROUND STORAGE

- Manhole access and observation ports checked. Small bits of sediment in sections. Sediment has not reached the 5% range. Recommend cleaning once the 5% level has been reached. Overall BMP in good condition.

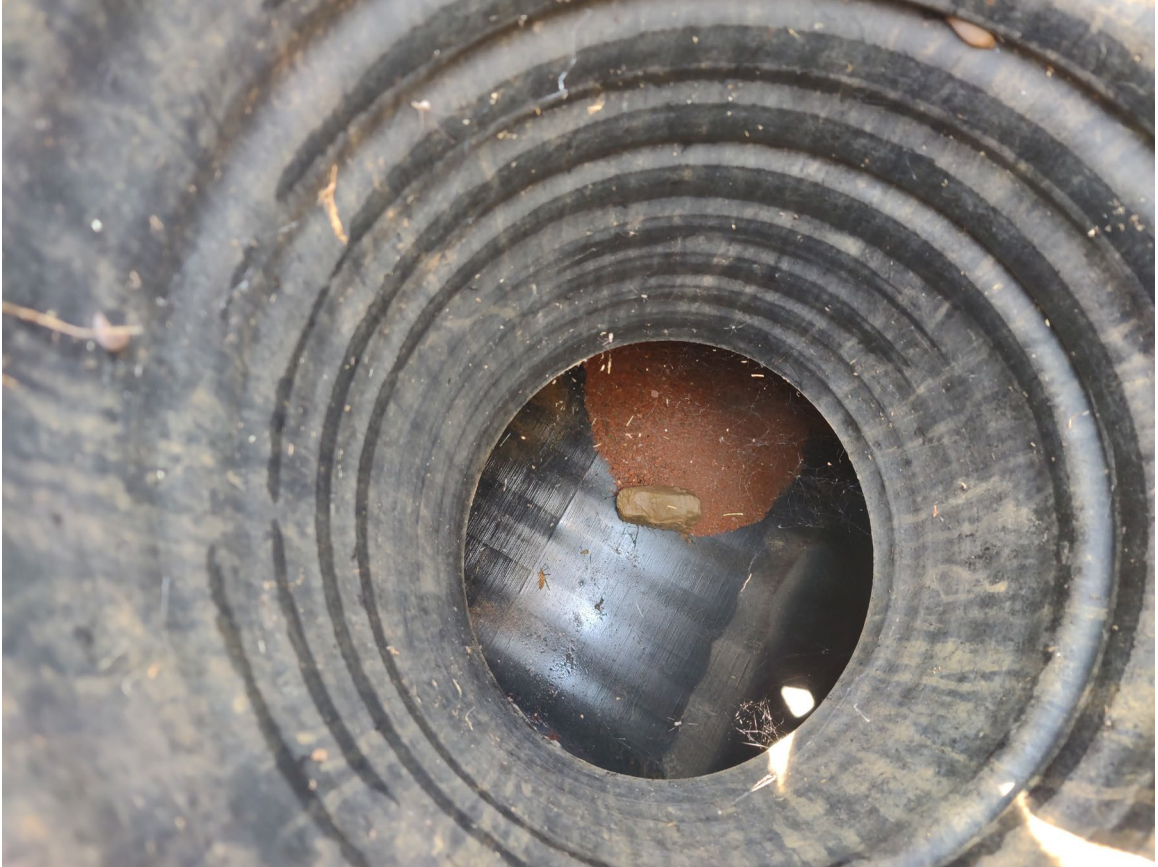
RU-BMP-HF-1 – UNDERGROUND STORAGE

- Sediment, pine needles and riprap in various sections of pipe and riser as well as the outfall. Sediment and debris observed within the structure requires removal. Based on the drainage basin to the BMP, most of the debris is coming from a culvert inlet structure.

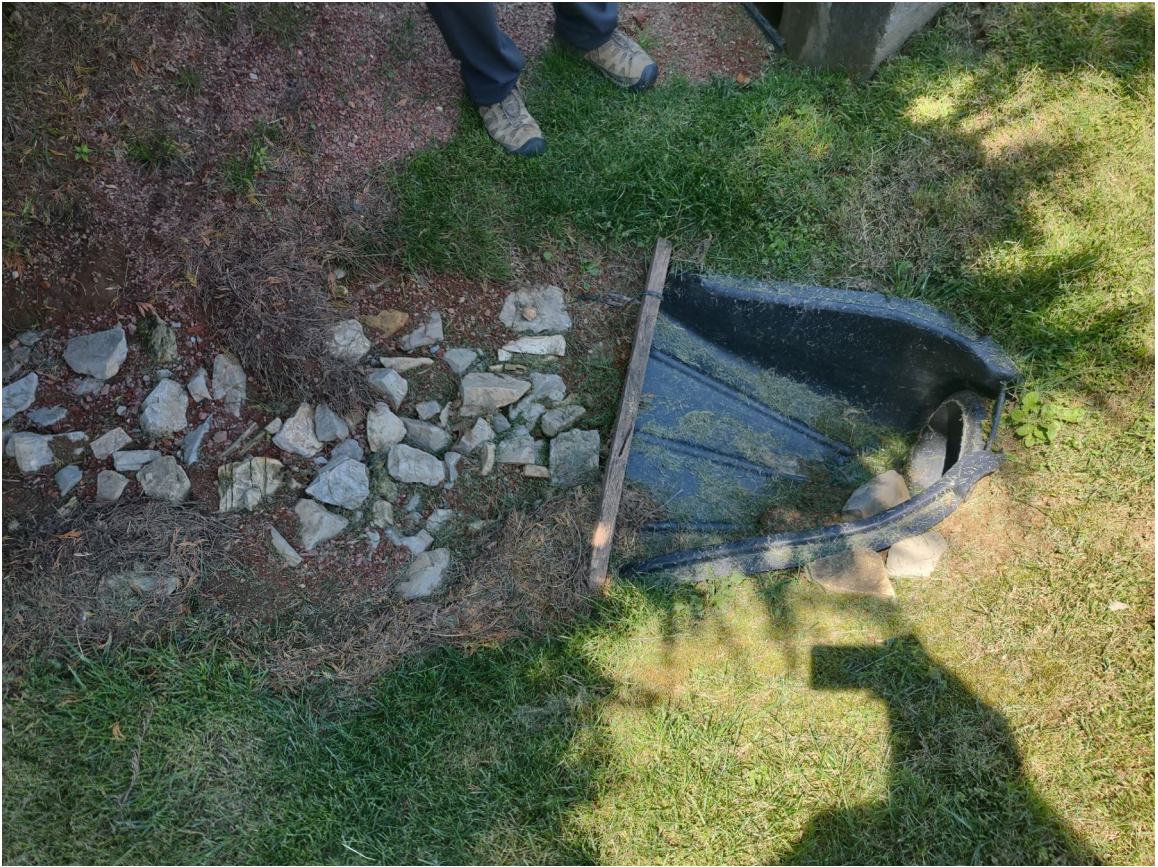
- Sediment, pine needles and riprap originate from the adjacent ballfield and screening pine trees along the outfield. This open culvert needs to be screened to prevent the sediment, needles and riprap from entering the underground detention facility.

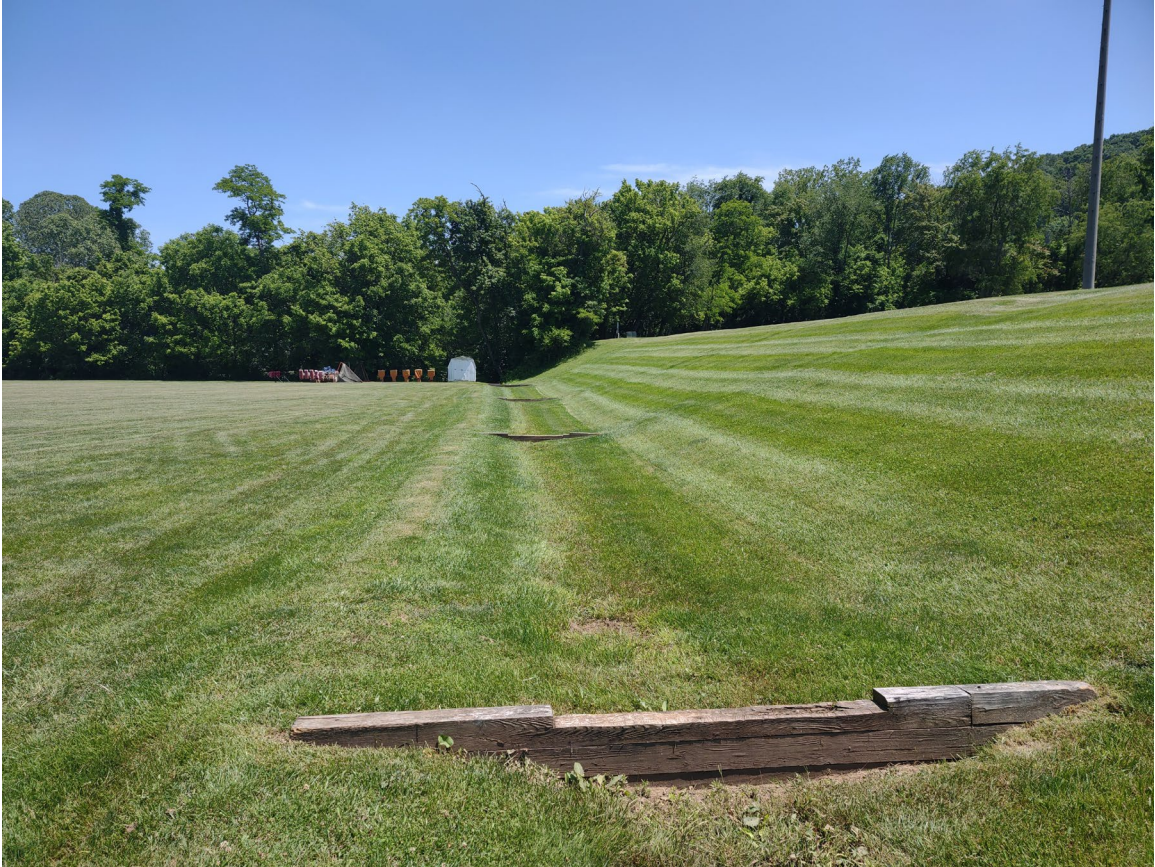
RU-BMP-HF-1 – GRASSED SWALE

- RU staff to continue to keep heavy mowing equipment off swale area to avoid bio media compaction. Site stable and well maintained. Check observation ports to make sure equipment is not damaging caps.

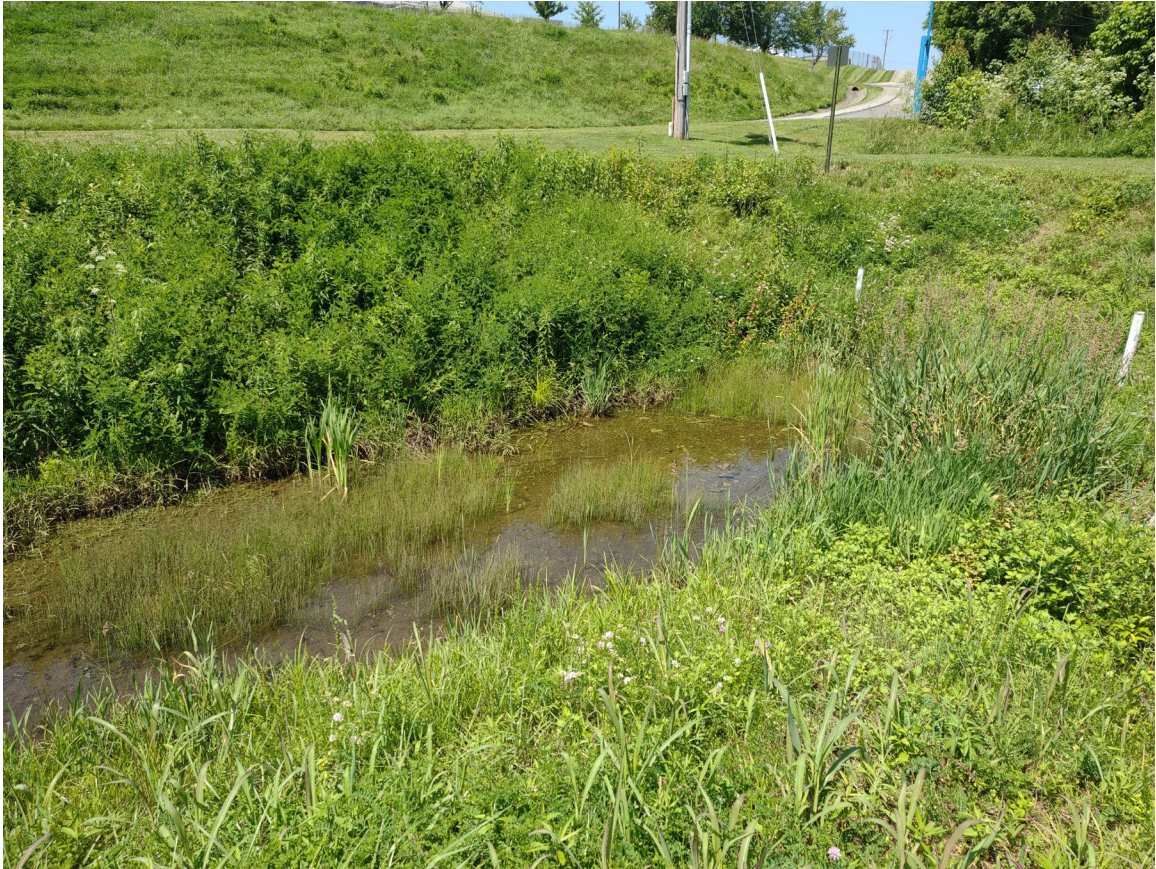
RU-BMP-WT-1 – CONSTRUCTED WETLANDS

- Overall site area has some areas of excessive vegetation; however, recent mowing allowed for easier access to all portions of the BMP from previous visits. Initial inspections started with the forebay area of the wetland. Some minor sediment buildup in the forebay. RU staff to monitor if sediment removal is required. It was noted that the sediment markers need a visible mark on them for determining maximum limit of sediment.

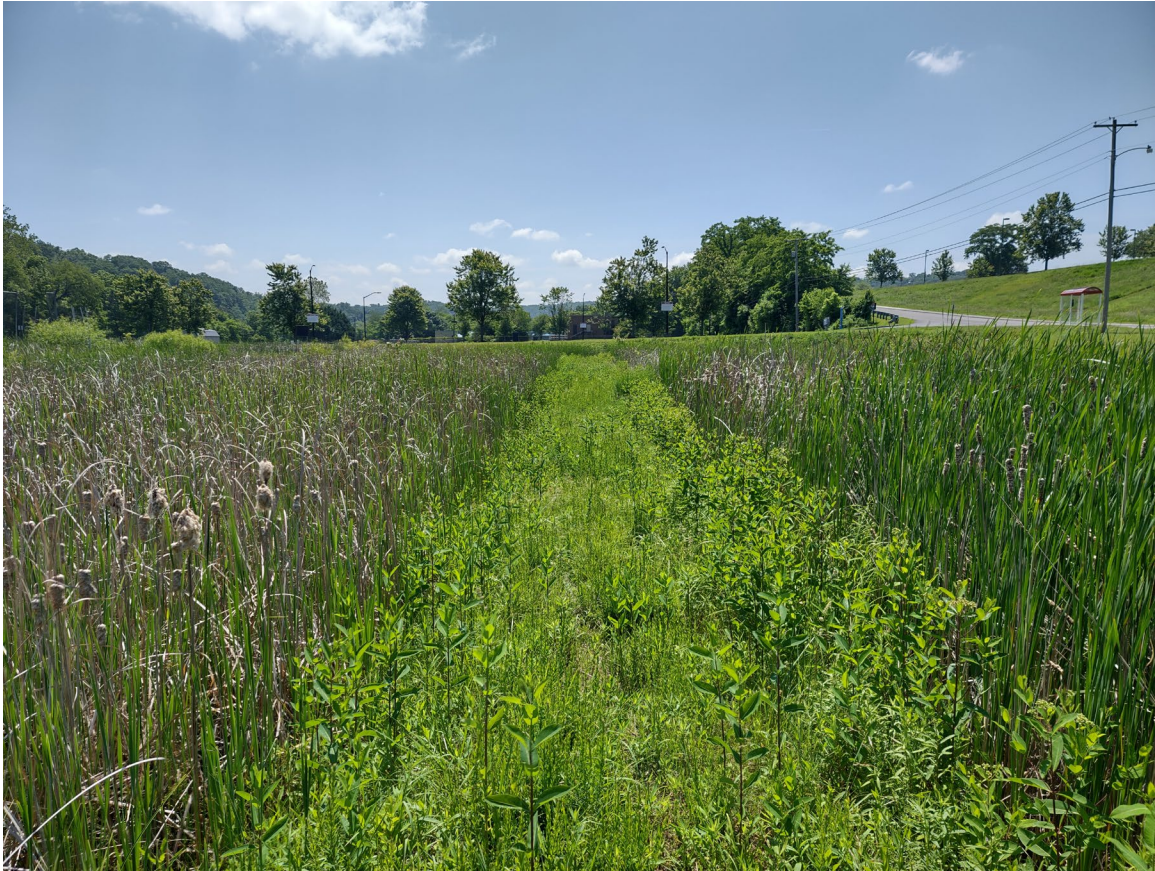
- Excess vegetation had been removed to allow access to the various cells within the wetlands. This allowed access to the internal areas of the wetlands. It was noted that the internal berms show signs of erosion in places due to higher storm events and should be monitored. Repairs may be necessary in the future to avoid short circuit of the serpentine system if an internal berm is compromised.

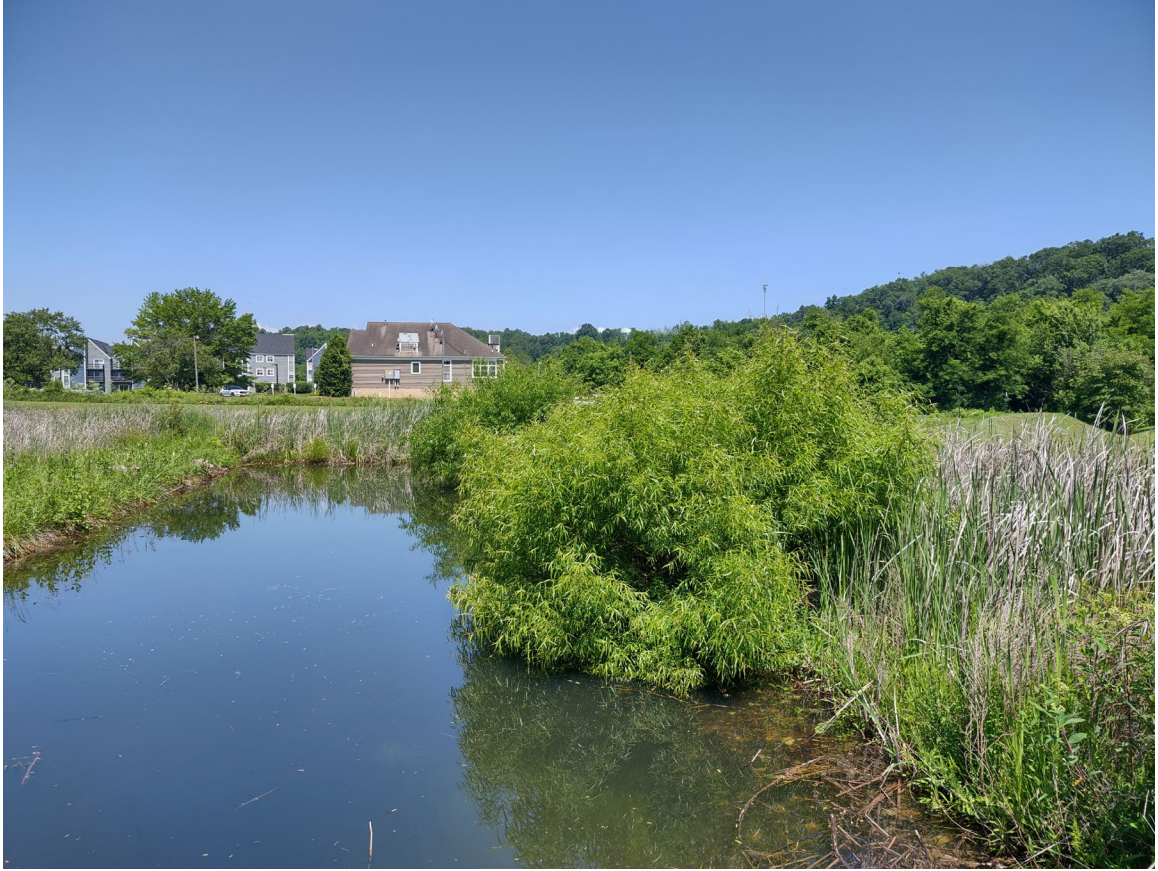
- Based upon the 2016 & 2018 reports, invasive species were identified in the wetland cells. The original plan has a schedule for the high and low marshes. Currently there are cattails and phragmites within the wetland area. Control of those invasive species should be implemented and monitored if they reach 15% of the wetland cell. RU staff should continue to monitor the extent of the invasive species.

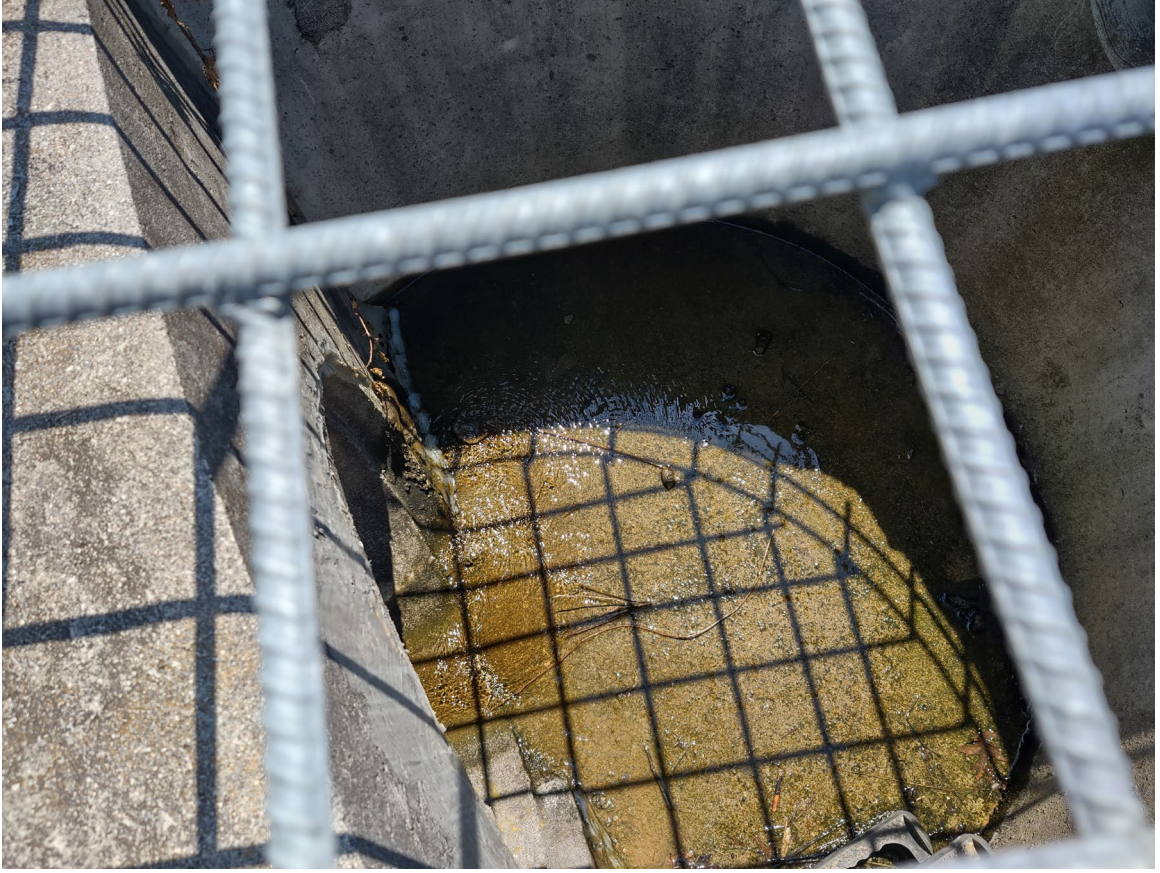
- Upon investigation of the riser and spillway areas of the BMP, it was noted that there was water emerging from cracks in the structure. Water was entering the riser and exiting the outfall pipe. This requires immediate repairs, or the wetland pond permanent pool elevations will drop and expose sections of the wetland area to dry conditions. It is recommended to excavate around the outer area of the riser and seal off the cracks in the structure to eliminate the seepage. Internal methods may be done but are not permanent and may require continuous applications.

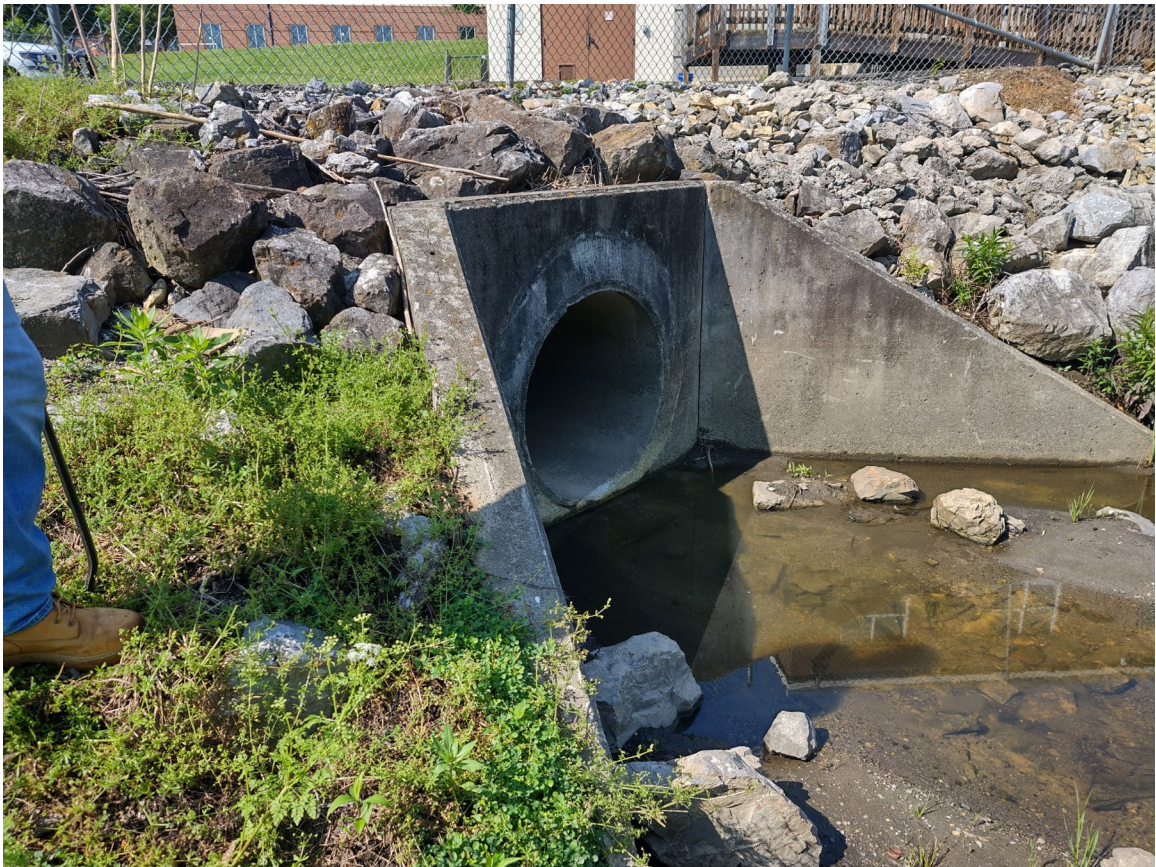
RU-BMP-AL-1 – DETENTION POND

- The University has seeded the pond to stabilize the facility. RU staff to maintain basin area and remove any excess debris. Recommend increasing the normal maintenance cycle.

Additional sediment has been deposited since the last scheduled removal of debris. Remove excess sediment from outfall area. RU staff to clean out bottom of basin and reseed. With a significant occurrence of sediment in the basin, further investigation is recommended. The drainage area to the basin is the area of Jefferson Street which does not show signs of sediment infiltration throughout the basin area. Therefore, it may be separation of the concrete pipes that may be allowing sediment to enter the basin. It is recommended to camera the pipe starting at the outfall into the basin. In addition to the investigation, riprap should be added to the outfall into the basin to help stabilize the bottom of the pond and reduce sediment flow.

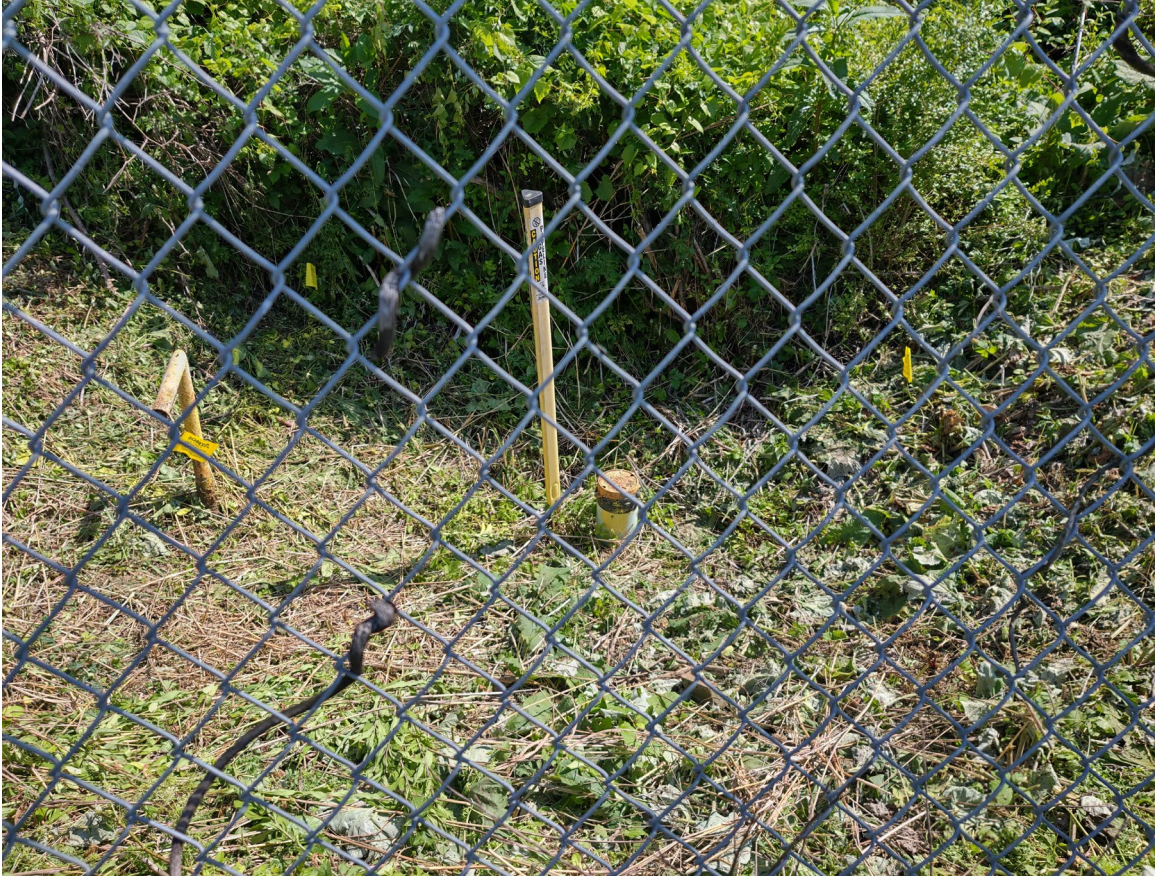
- As reported in the last inspection, the berm area near the gas line installation shall continue to be monitored for seepage or compromise. No signs of erosion or seepage during this inspection.

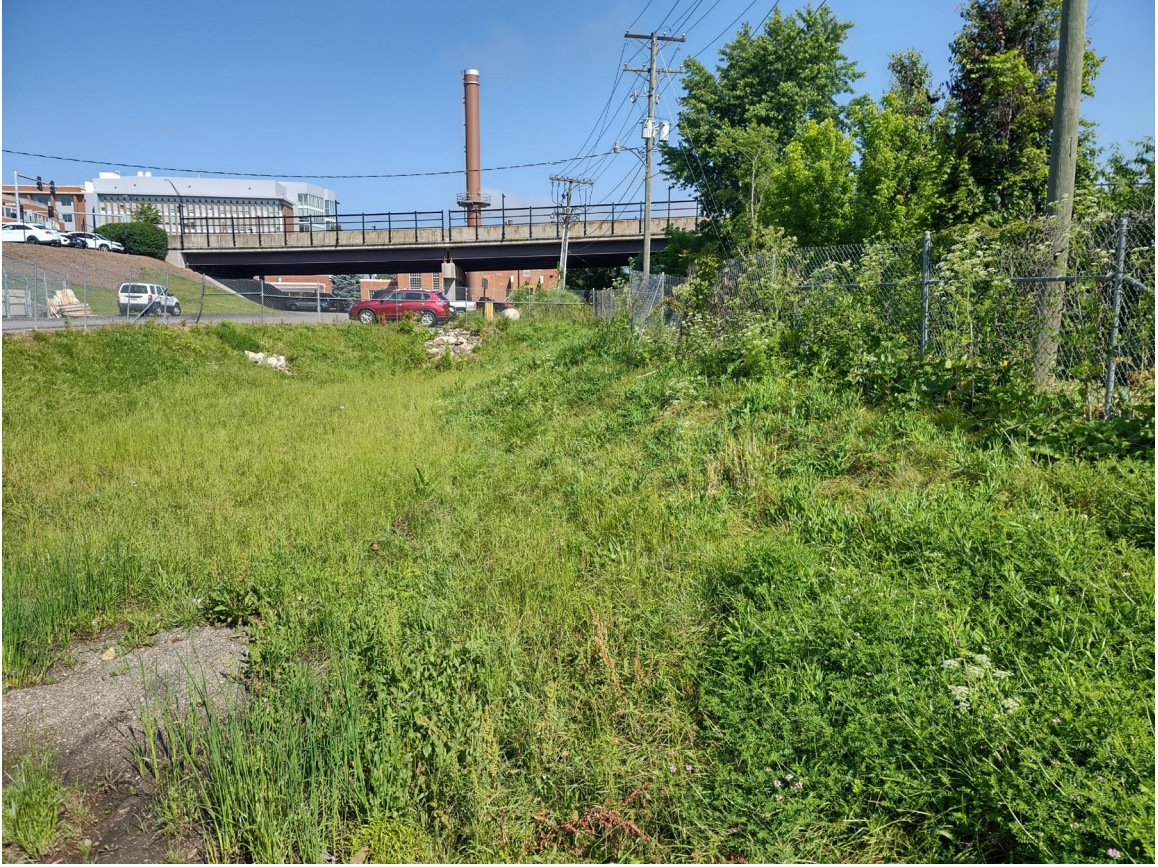
- A vermin hole was located along the berm near the gas line area. Traps should be set to capture the vermin and remove it from the basin area.

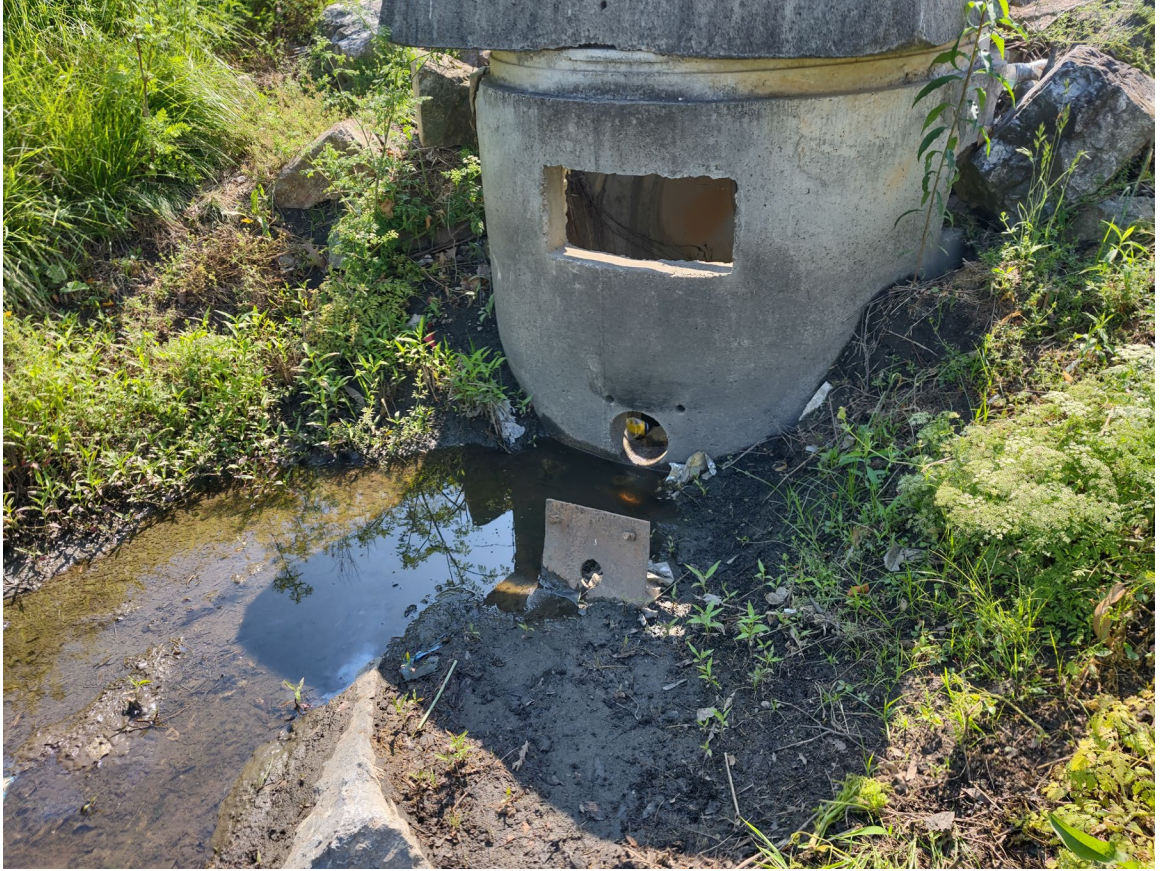
- The riser sections require cleanout and the trash rack for the lower orifice needs to be repaired.

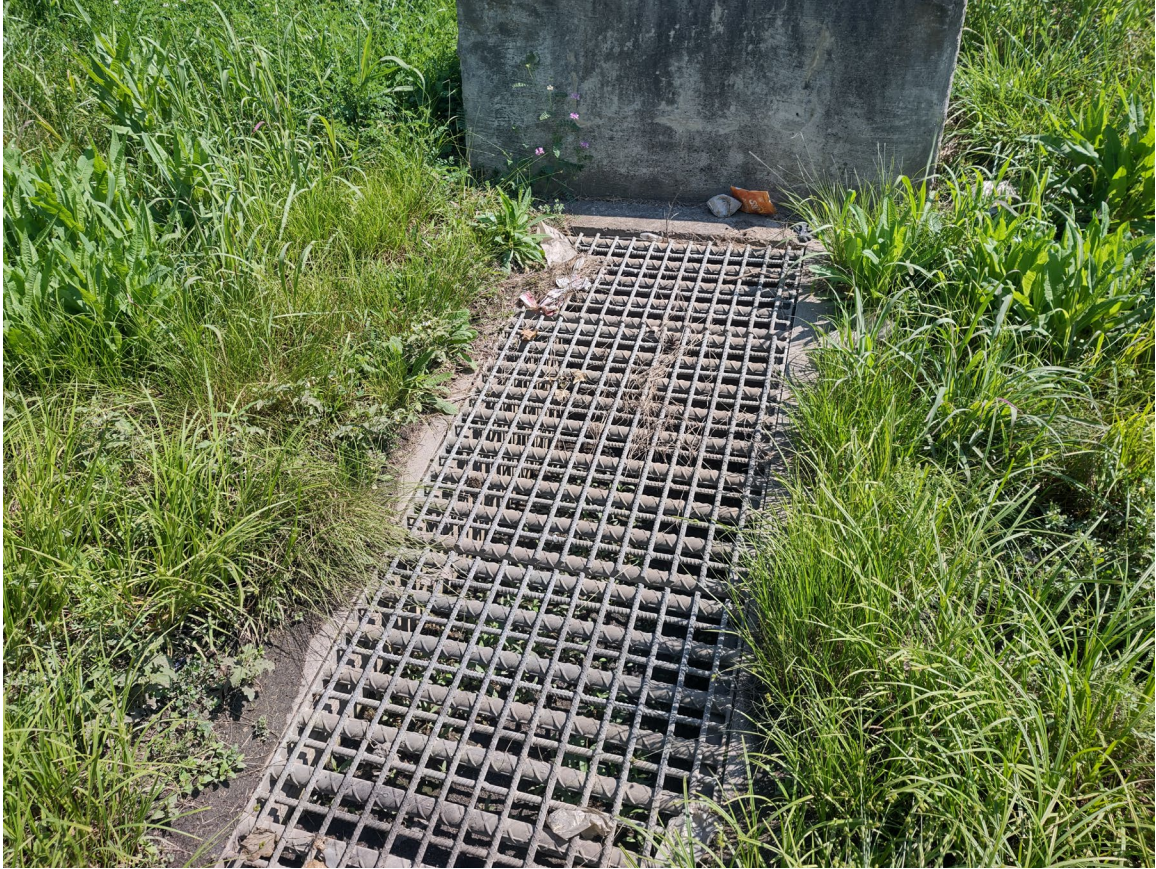
RU-BMP-AR-1 – DETENTION POND

- RU has seeded the pond area for stabilization of the BMP. RU staff to maintain basin. It is recommended to increase the frequency of the maintenance schedule.

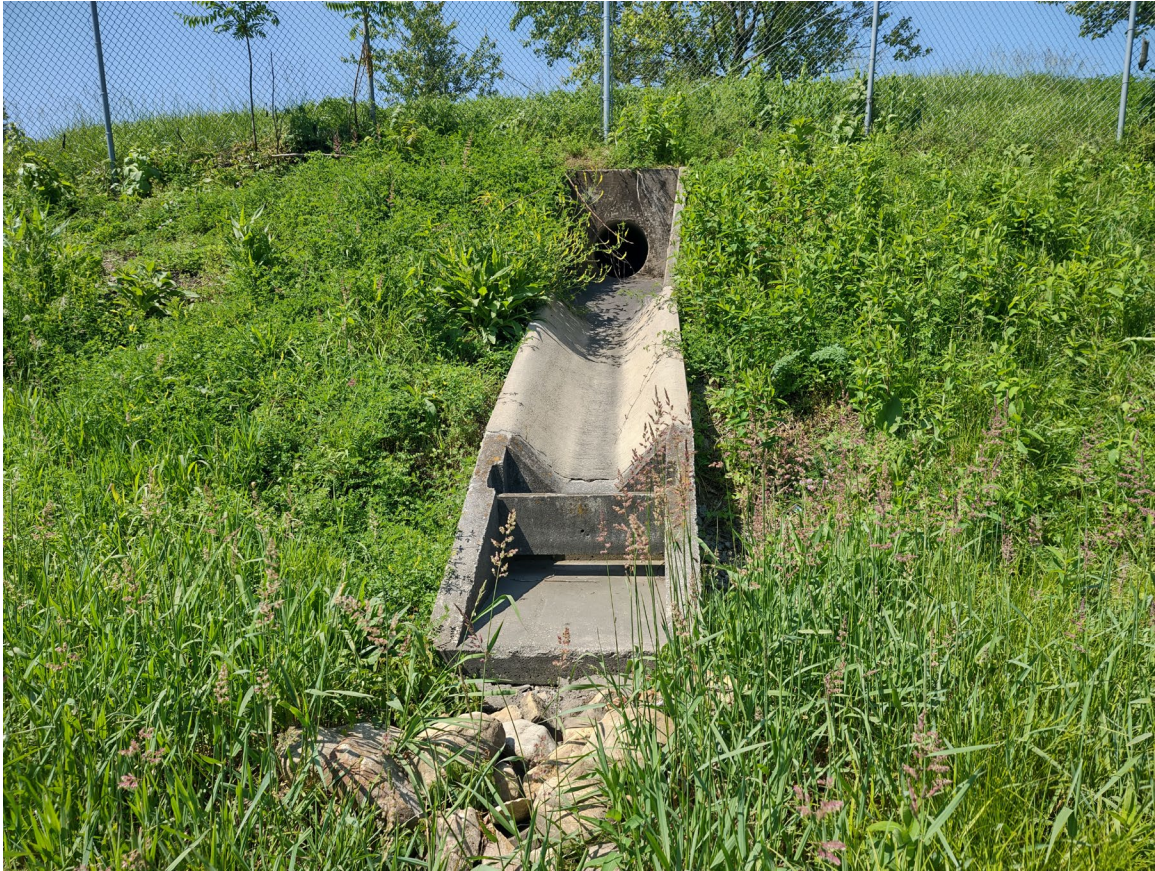
- Inlet pipe with outfall concrete channel showed signs of separation which resulted in erosion around structure in 2018. RU staff replaced the structure to prevent further erosion on outfall channel. New paved flume shows some signs of cracking near the bottom of the structure. RU staff to monitor.

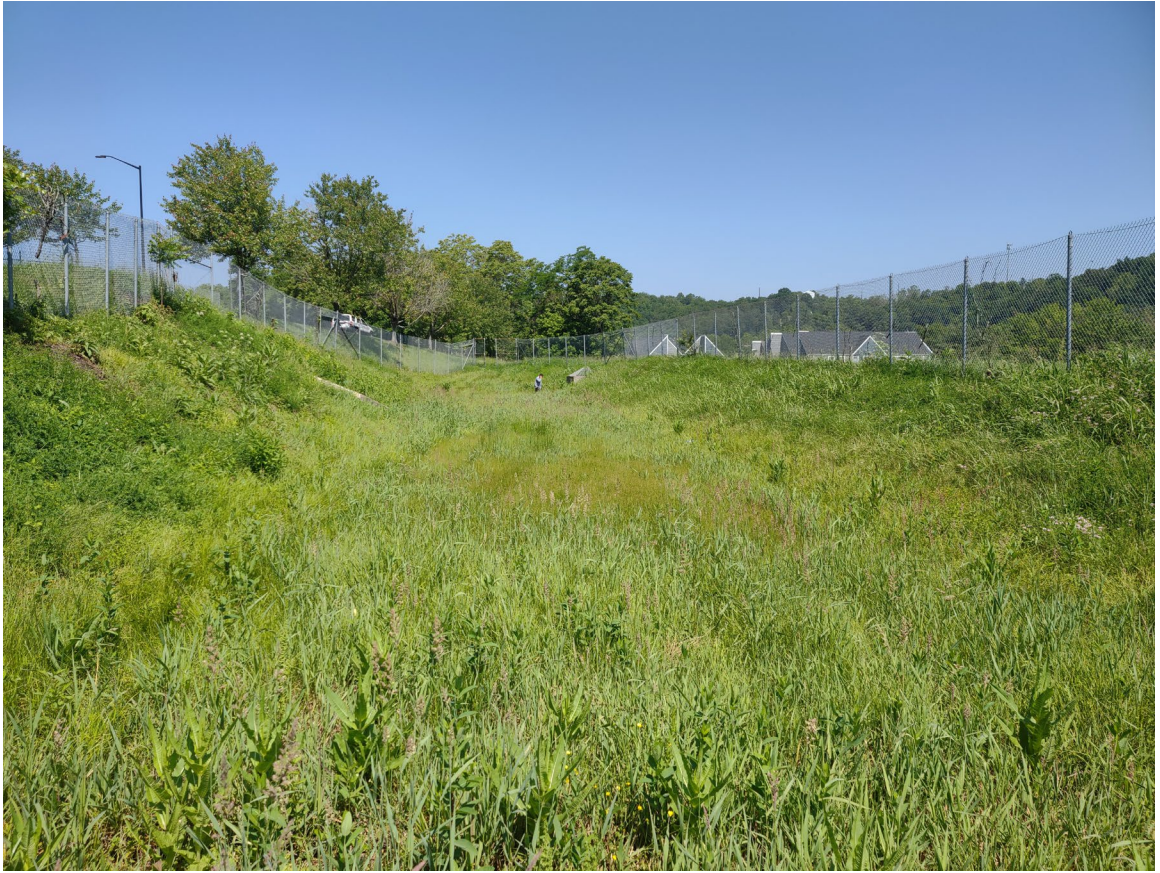
- Nuisance animals had been noted to be in the area of the BMP and have been caught in recent years. RU staff to keep traps out and fill holes immediately. Recent inspection has discovered additional signs of holes along the downstream portion of the basin. Set traps to capture vermin and remove from the area. Recommend increasing the schedule for mowing to allow for better inspection of the berm structure.
- Clean out sediment from center of the basin. It was noted that sediment build-up in sections do not allow portions of the pond to drain to the riser section which leaves standing water.

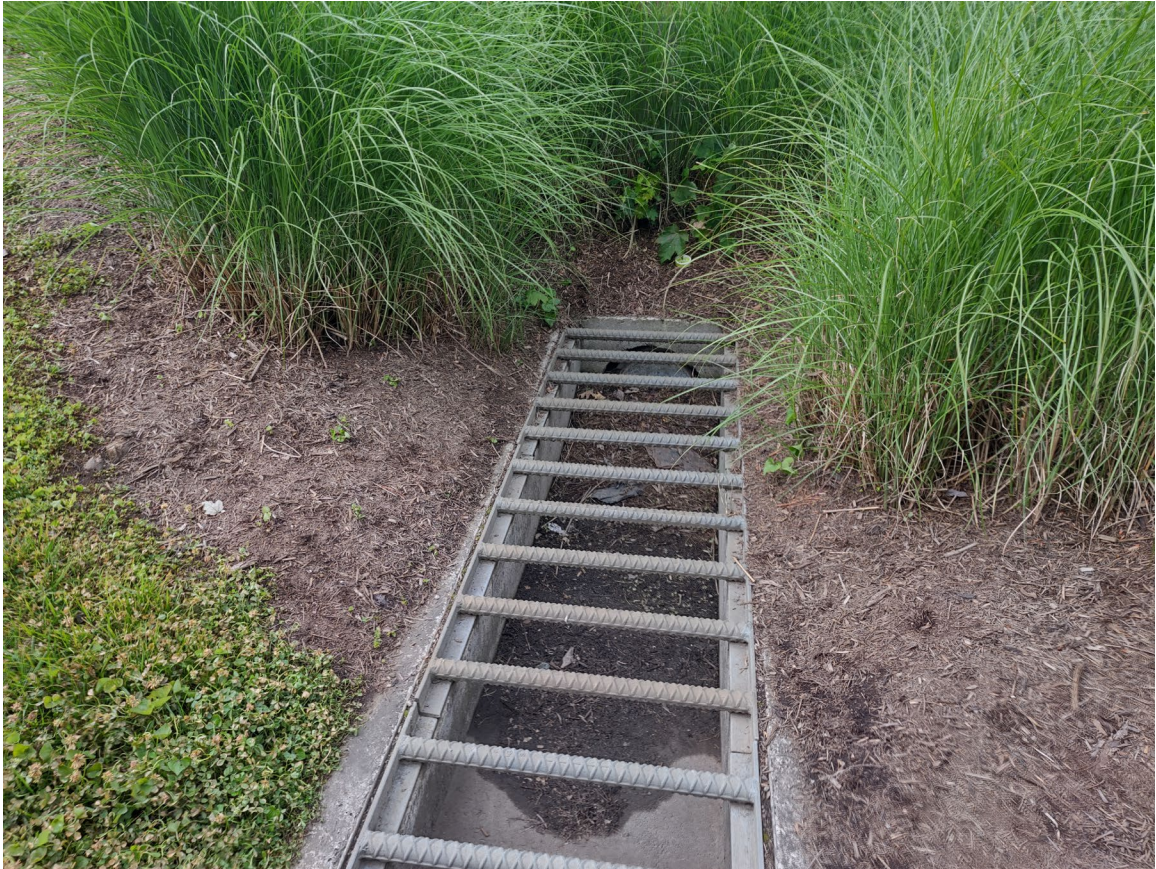
RU-BMP-CH-1 – DETENTION POND

- Overall, the facility has been kept in good condition. RU staff will continue to pick up trash and debris. Some plant debris and mulch from the adjacent area. Recommend installing a border around the inlet to keep adjacent mulch from entering the structure.

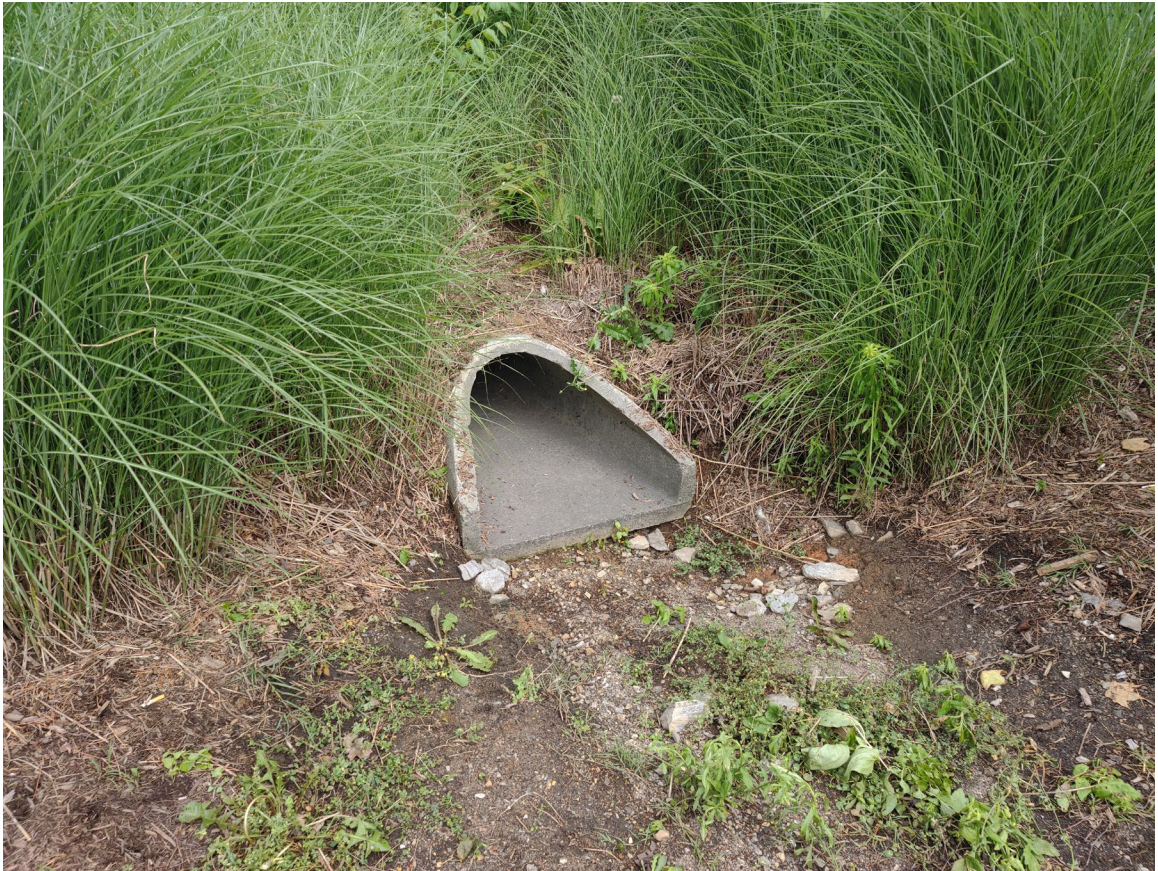
- Add riprap to the outfall section. Noted sediment of gravel mixture buildup at outfall. Source was traced to parking lot. Monitor and remove sediment and debris as needed.

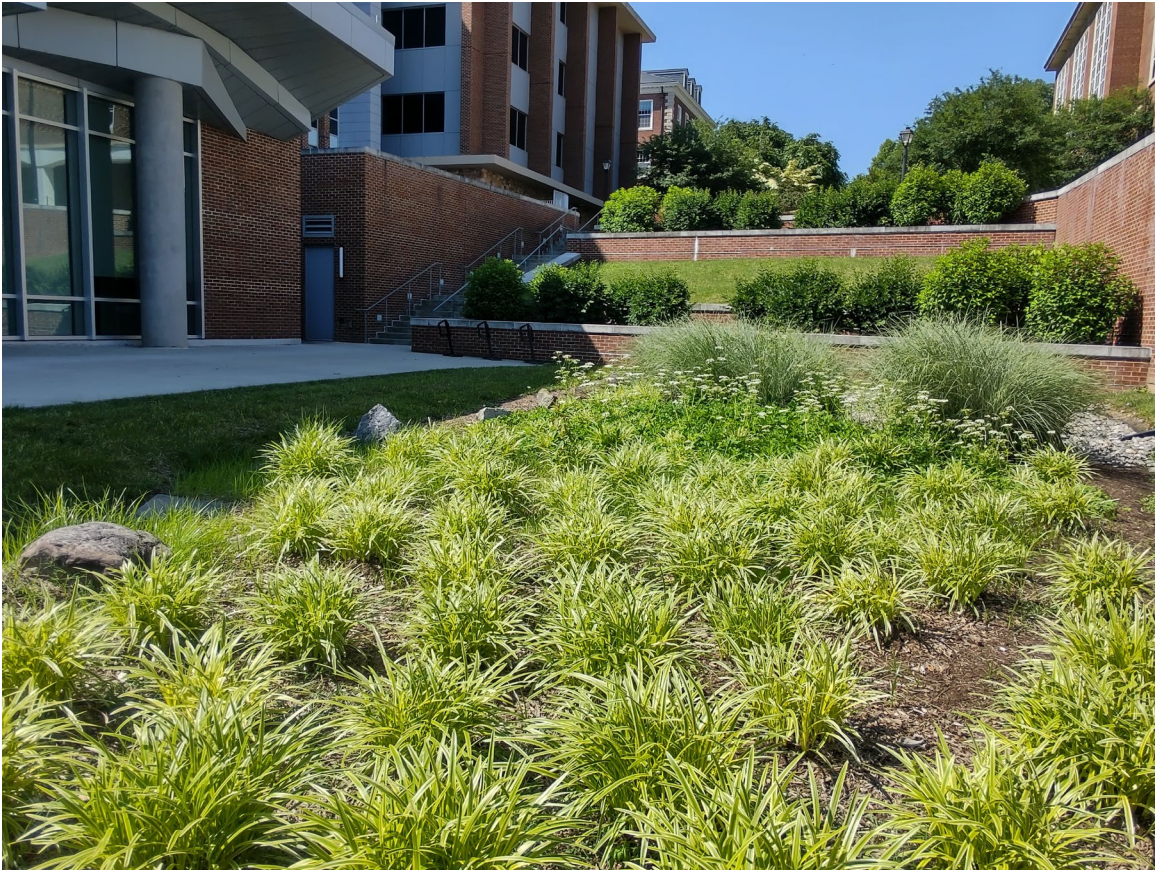
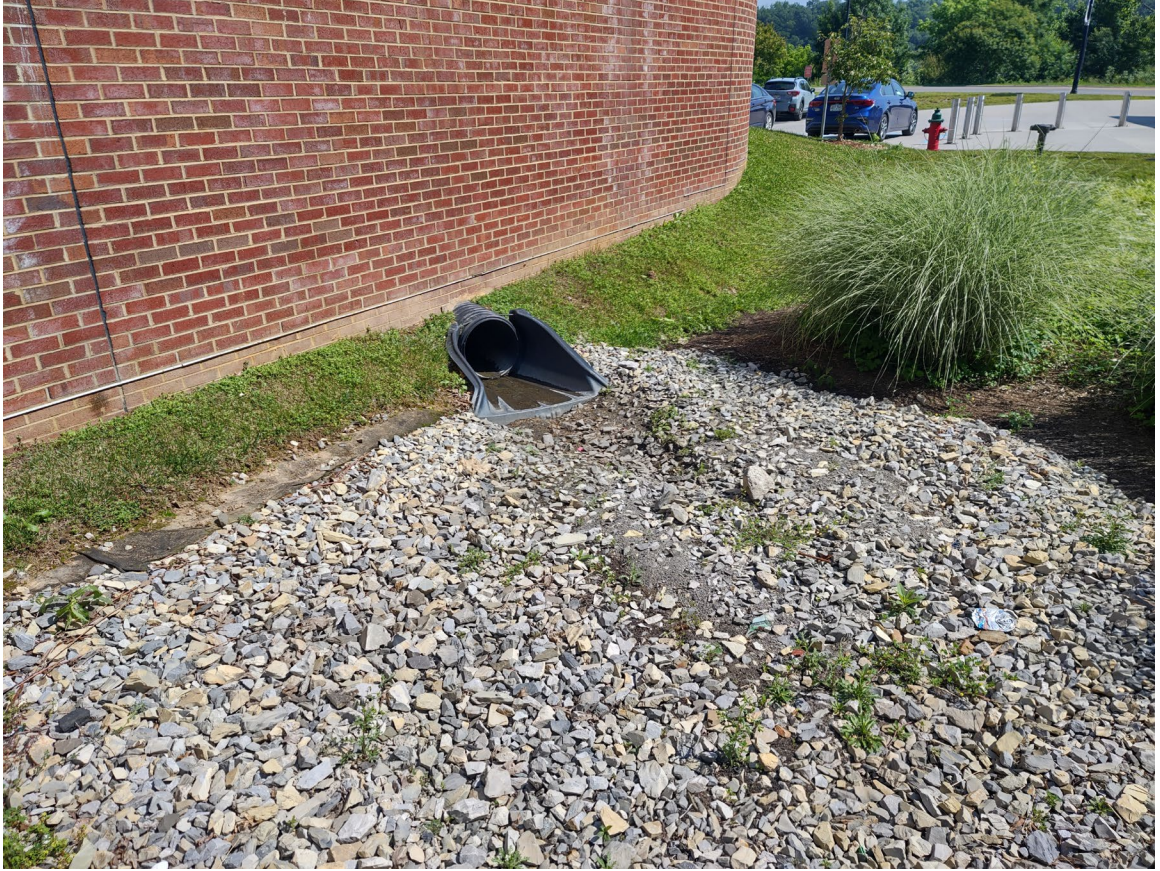
RU-BMP-SC-1 – BIORETENTION

- The BMP is in good condition with some apparent trash from drainage area. Plants and mulch have been maintained. No issues with the underdrain or media. Cleaned up and removed some debris noted in the forebay area. Minor weeding required for a few sections of the bioretention.

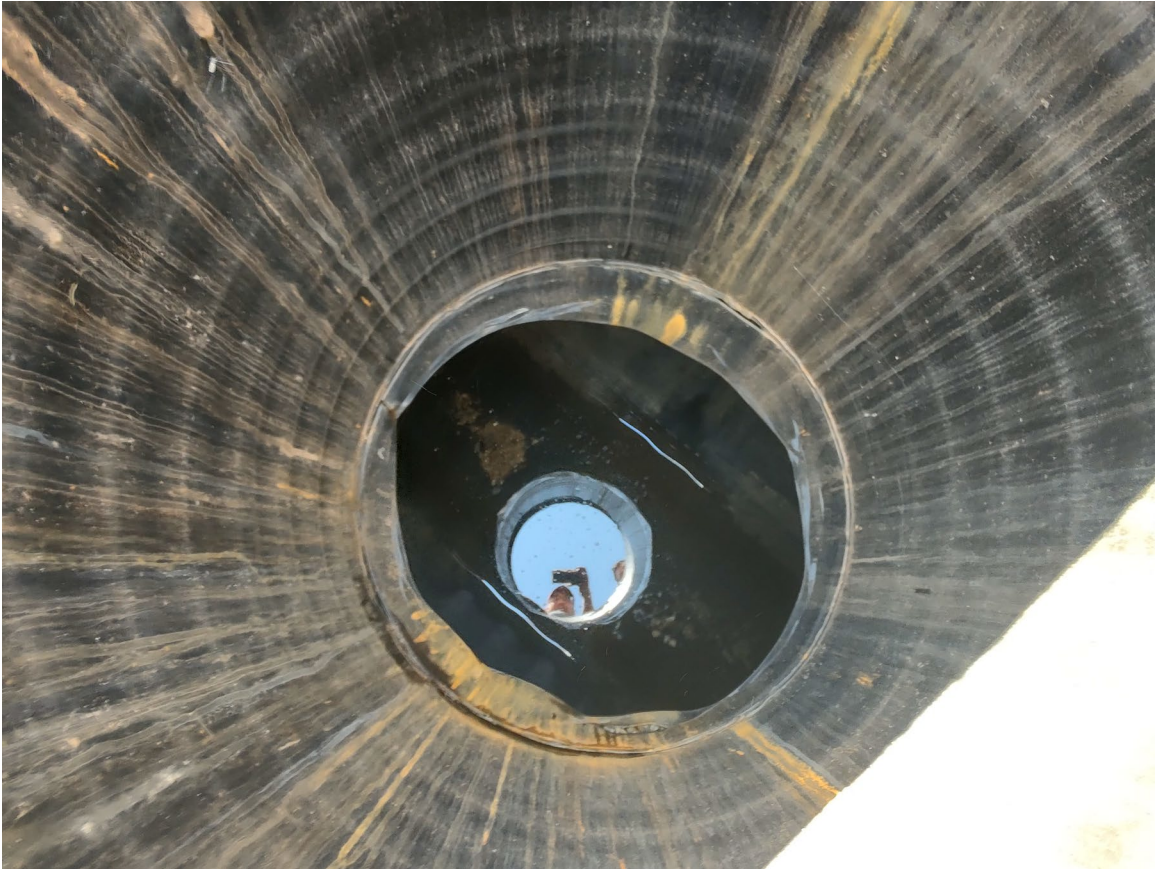
RU-BMP-HU-1 – UNDERGROUND DETENTION

- Sediment in structure, however, less than 5%. Removal of sediment is required once 5% has been reached to ensure proper function of detention system. It is still noted that the Humanities Building HVAC units send condensation water to the facility at various times. Outfall was checked to ensure no blockage was impeding flow.

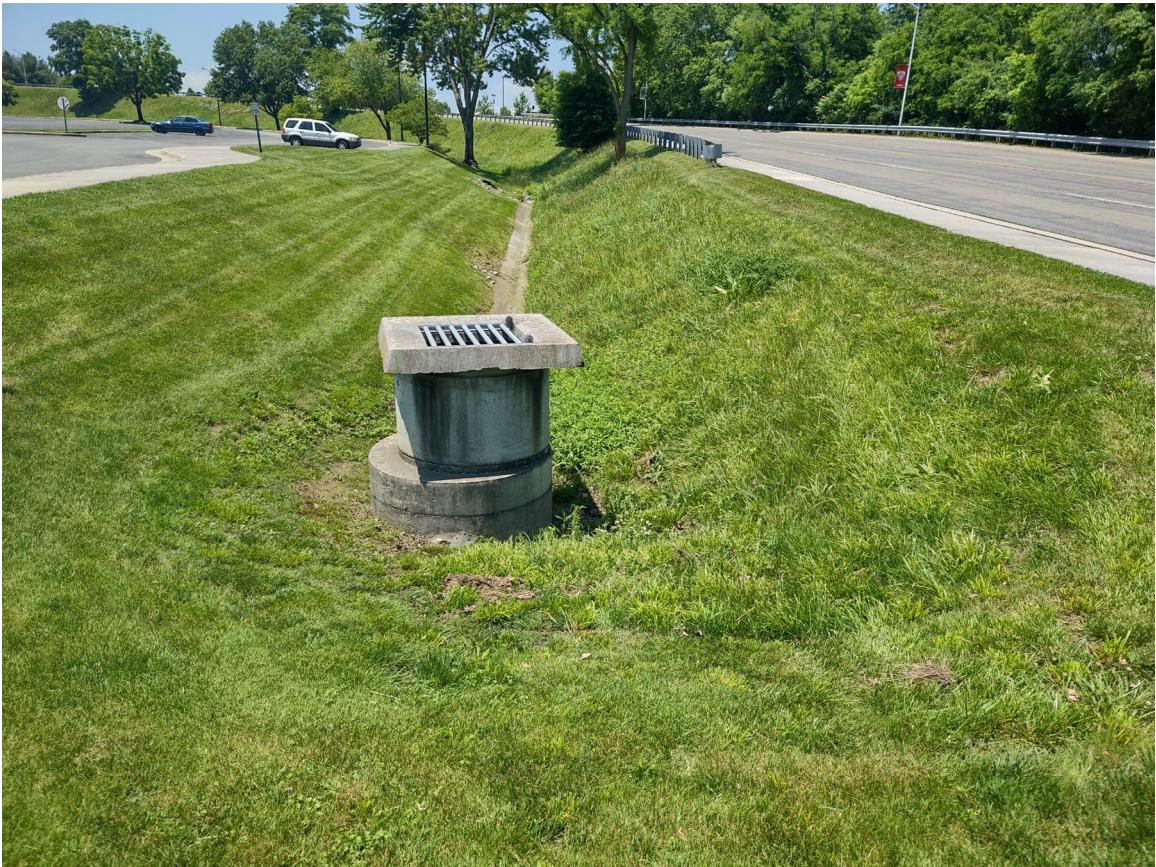
RU-BMP-CU-1 –DETENTION POND

- Overall facility is in good condition with no signs of erosion near the roadway. However, there were some signs of erosion around the back of the riser section. Recommend select backfill and seeding of the area.
- Recommend increasing the schedule for vegetation removal along the slopes. Some excess vegetation in a few areas.
