RADFORD UNIVERSITY

BMP INSPECTION REPORT

Project Number: 2429.3

Date: July 1, 2023

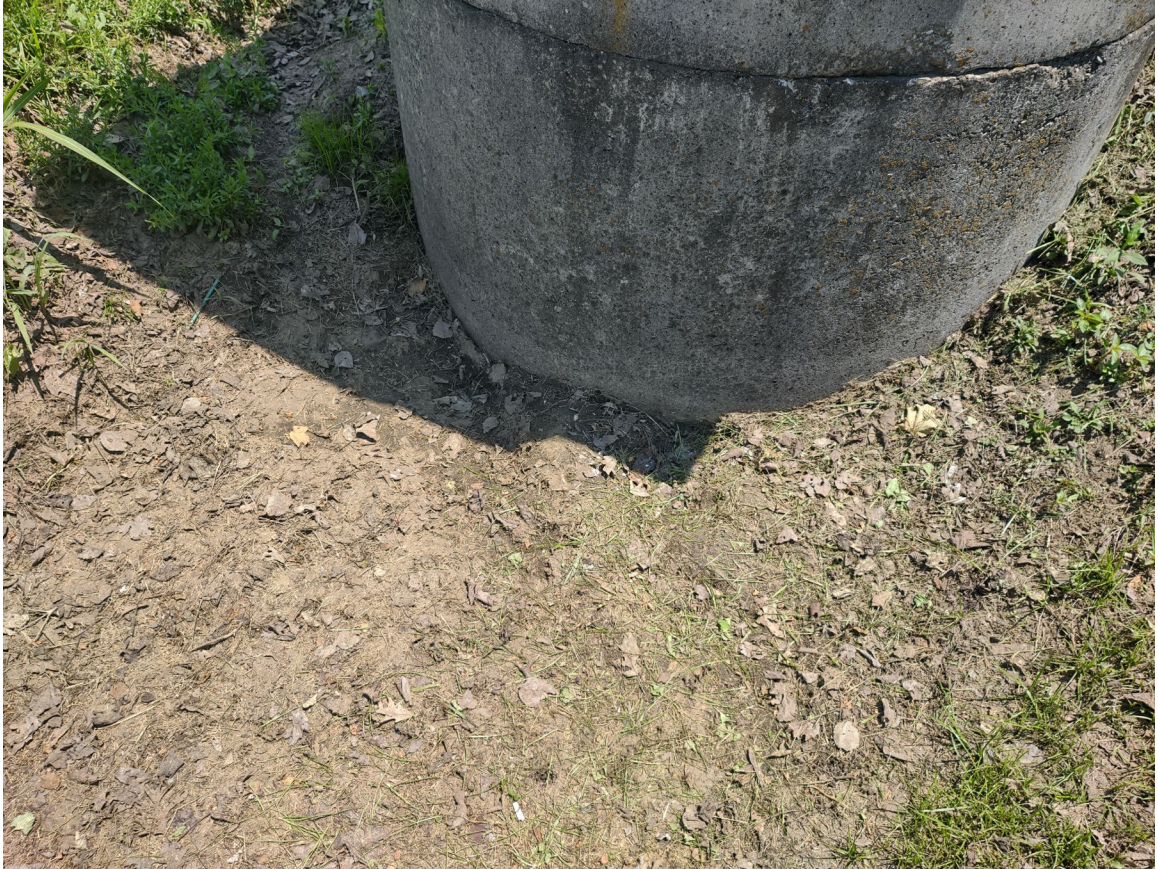
- Debris and sediment found near the riser orifice. Sediment blocks lower orifice from functioning. Remove Immediately.

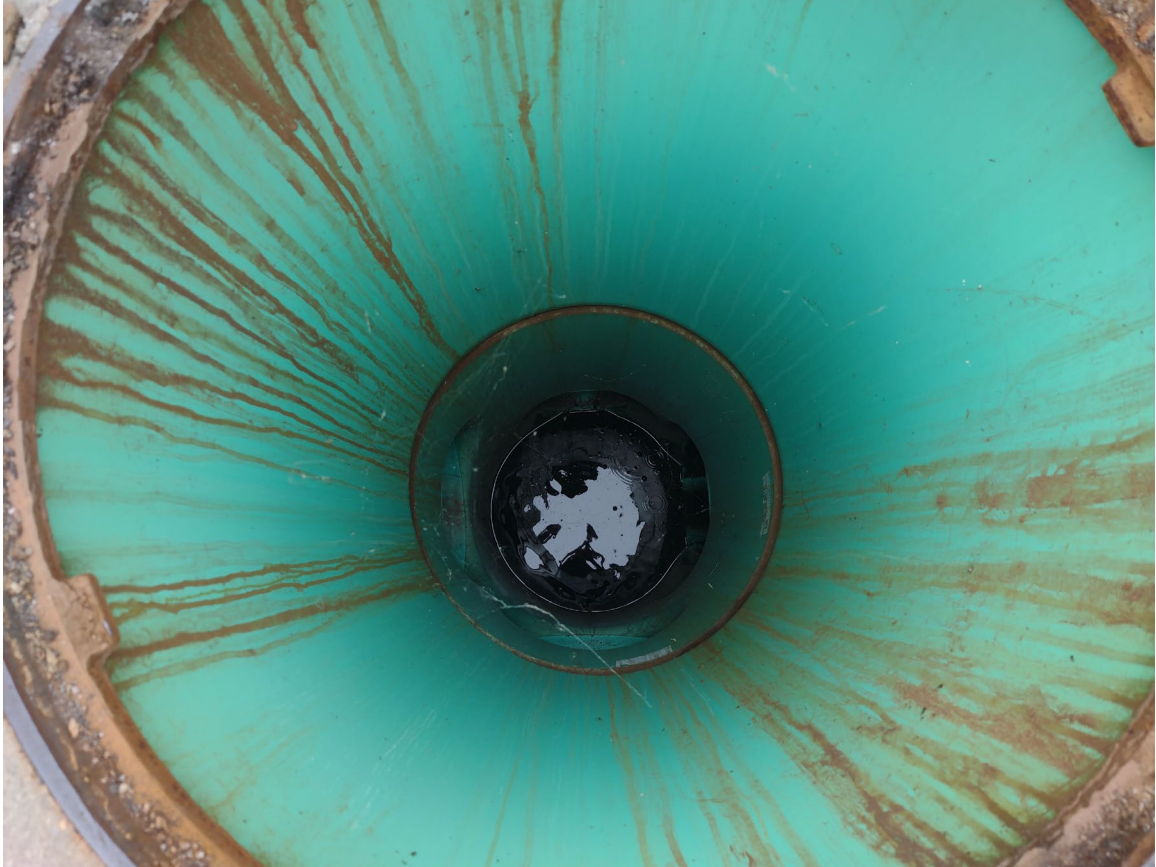
RU-BMP-FF-1 –UNDERGROUND DETENTION POND

- Overall, facility is in good condition since it is still somewhat relatively new. There has been no sediment accumulation occurring so far; however, the internal sides of the observation manhole show moments of small amounts of sediment. System should continue to be monitored.
